Final Infiltration and Inflow Report

Village of Merrickville-Wolford
Merrickville, Ontario

The Village of Merrickville-Wolford
Project File No. 19-5031D

June 2022

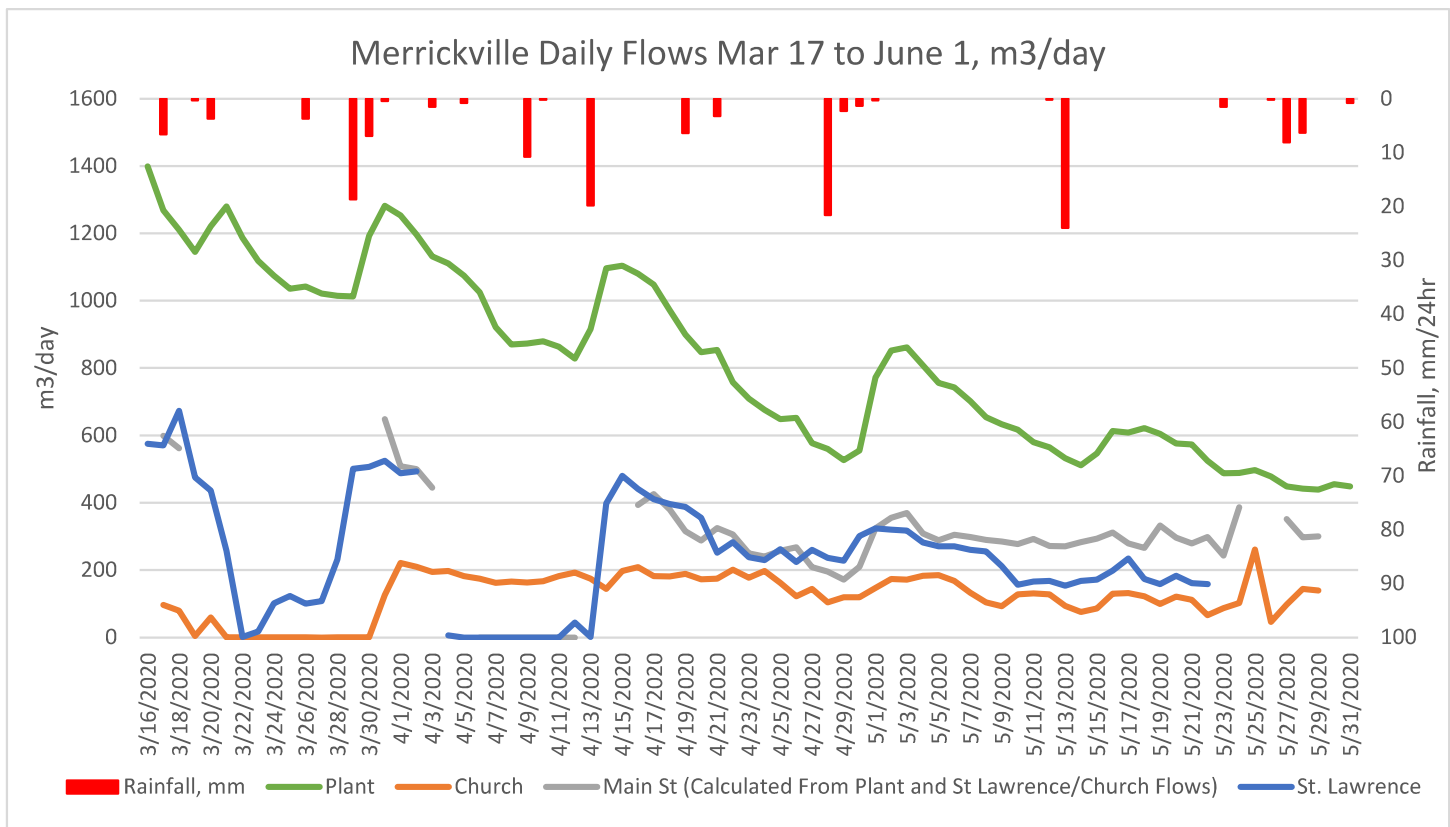
Figure 2: Merrickville Flows March 17th to June 1st, 2020

The flow data gathered in 2019 was adjusted to decrease the flow monitor values by 25%. The effect of this was to increase the calculated flow for Main Street which is the difference between the plant flow meter and the two flow monitors. The collected flow information for the plant and for each catchment area is provided in the figure below.

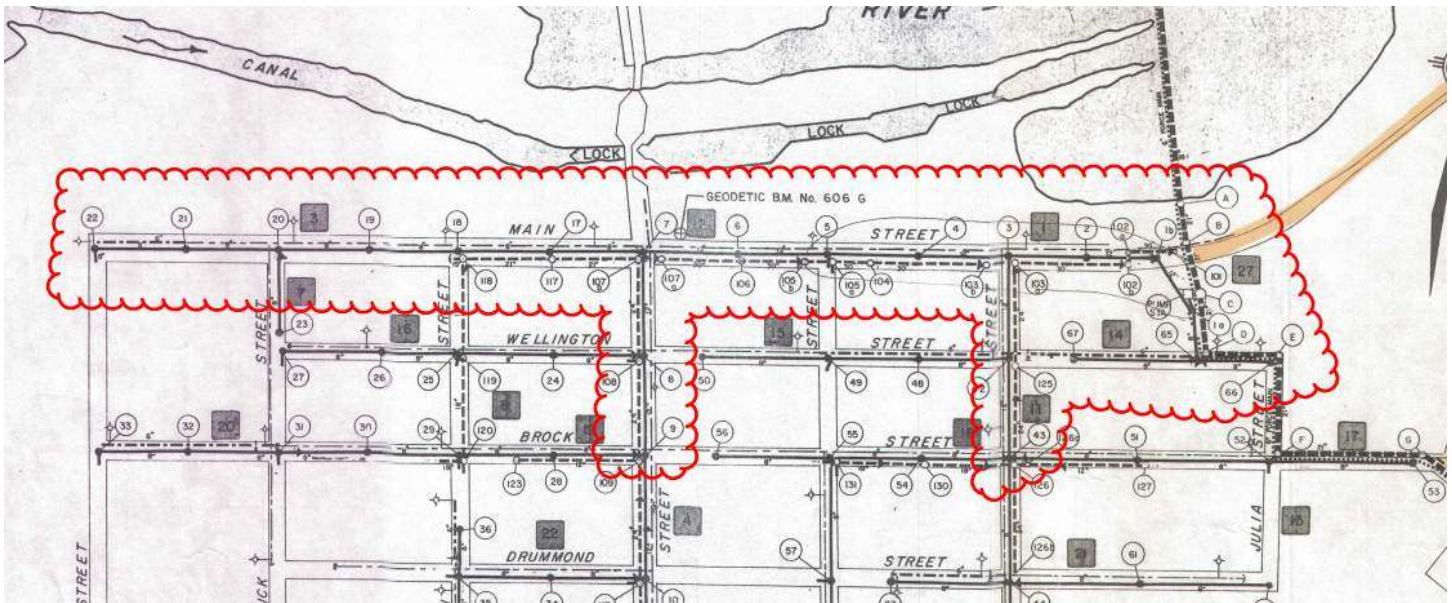
Figure 4: Manhole Structure Review Area June 2020

The first review of manhole structures was performed on June 5, 2020. Manholes along Main Street and two blocks south along St. Lawrence and Church Street, as shown in the figure below, were reviewed. No major concerns were noted in the manholes with very few cracks being noted, little evidence of streaking from water infiltration, and no major issues with manhole covers or frames. Detailed results of the review can be found in Appendix A.

In general the manholes were in good condition and very little inflow was observed through the structures. Some minor issues were recorded as follows:

Water through cracked risers inside manhole: SAMH-30, SAMH-24, SAMH-03.

Water through loose frame: SAMH-13, SAMH-28.

Water through leaky service connection to barrel of manhole: SAMH-33 (service from 354 Read), SAMH-06.

Provide grouting of cracked risers inside manhole: SAMH-30, SAMH-24, SAMH-03.

Repair loose frame: SAMH-13, SAMH-28.

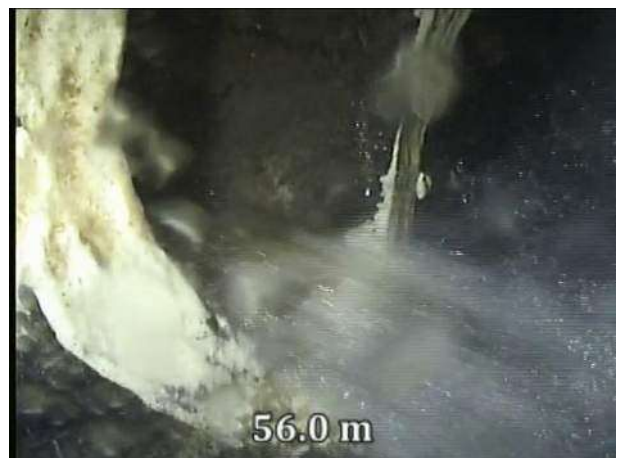
Figure 6: CCTV Report Extreme Inflow Noted at Main St and St. John

The CCTV report identified a significant source of inflow as follows: the branch connection between MH038 and MH039 on Main Street, very close to St. John Street, labeled “EXTREME INFLOW” and “INFLOW @ 54.5 S/C IS #205 MAIN ST W” . Refer to Figure 6, from the CCTV report.

This connection was repaired in March 2021.

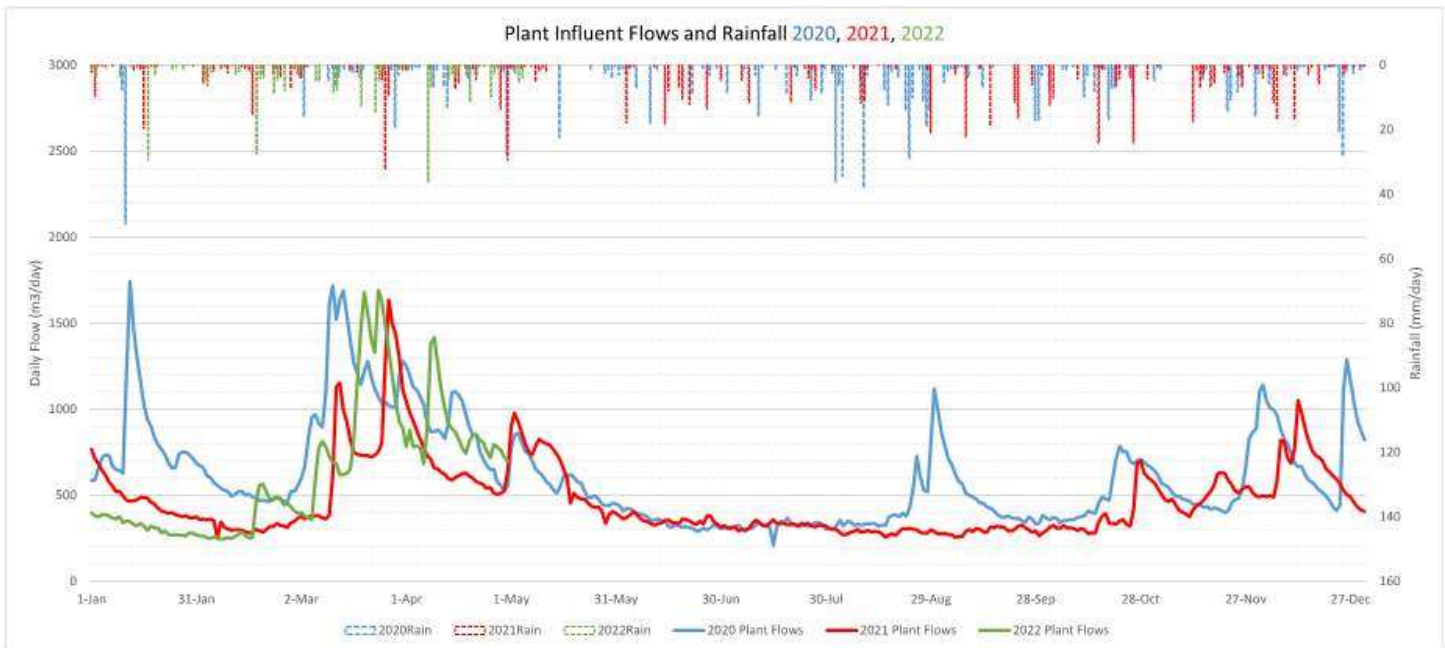
Figure 7: Plant Influent Flows and Rainfall, 2020, 2021, 2022

Plant flows have been tracked and compared year-to-year along with rainfall information gathered from Environment Canada for Drummond Centre (30km away) and Kemptville (20 km away). In this time frame the peak flows in spring have consistently risen to approximately 1700m³/day. Overall system flows in this time frame have been lower than the 5-year average. This is possibly due to lower amounts of precipitation, ongoing grouting work reducing infiltration and inflow, or a combination of both. There have been no incidences of plant effluent exceeding parameters due to high flows.

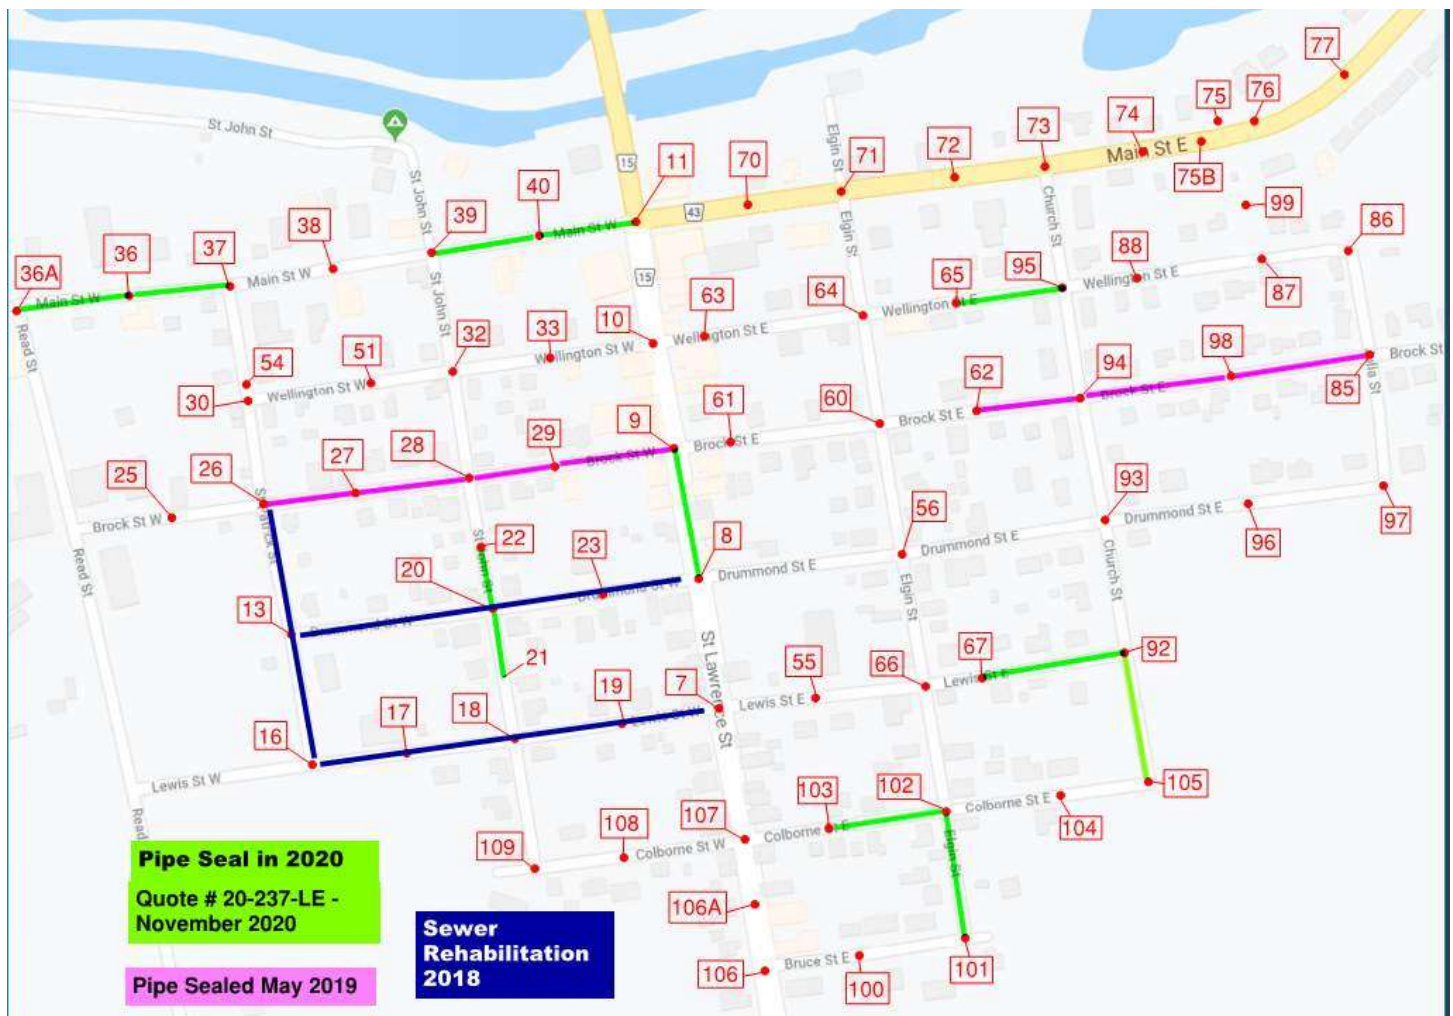
Figure 8: Scope of Sewer Repair Work 2018 - 2020

Grouting has been performed at cracks identified by CCTV review in the areas shown on the map below.

CCTV inspection has been performed by OCWA and Clean Water Works and has formed the basis of the grouting work which has been completed in 2019 and 2020 (map shown below). Operators have reported noticeable flow reductions from the work that has been performed so far. It is recommended that this process of CCTV review and pipe grouting be instituted as a permanent program performed annually to completely review the entire system and also monitor for new breakages that may appear as the system ages. We also recommend focusing the next stage of camera review on Main Street East between St. Lawrence Street and Charlotte Street where the system flows are the highest and the ground water is presumed to be highest. This section of the system is the most challenging to review as the piping is nearly completely full so temporary bypass pumping would be required to draw down the water to allow camera inspection, which is best performed at night when system flows are lowest. A budgetary figure from CWW for this work is \$36,000 - \$50,000. A detailed breakdown of this work is provided in Appendix B

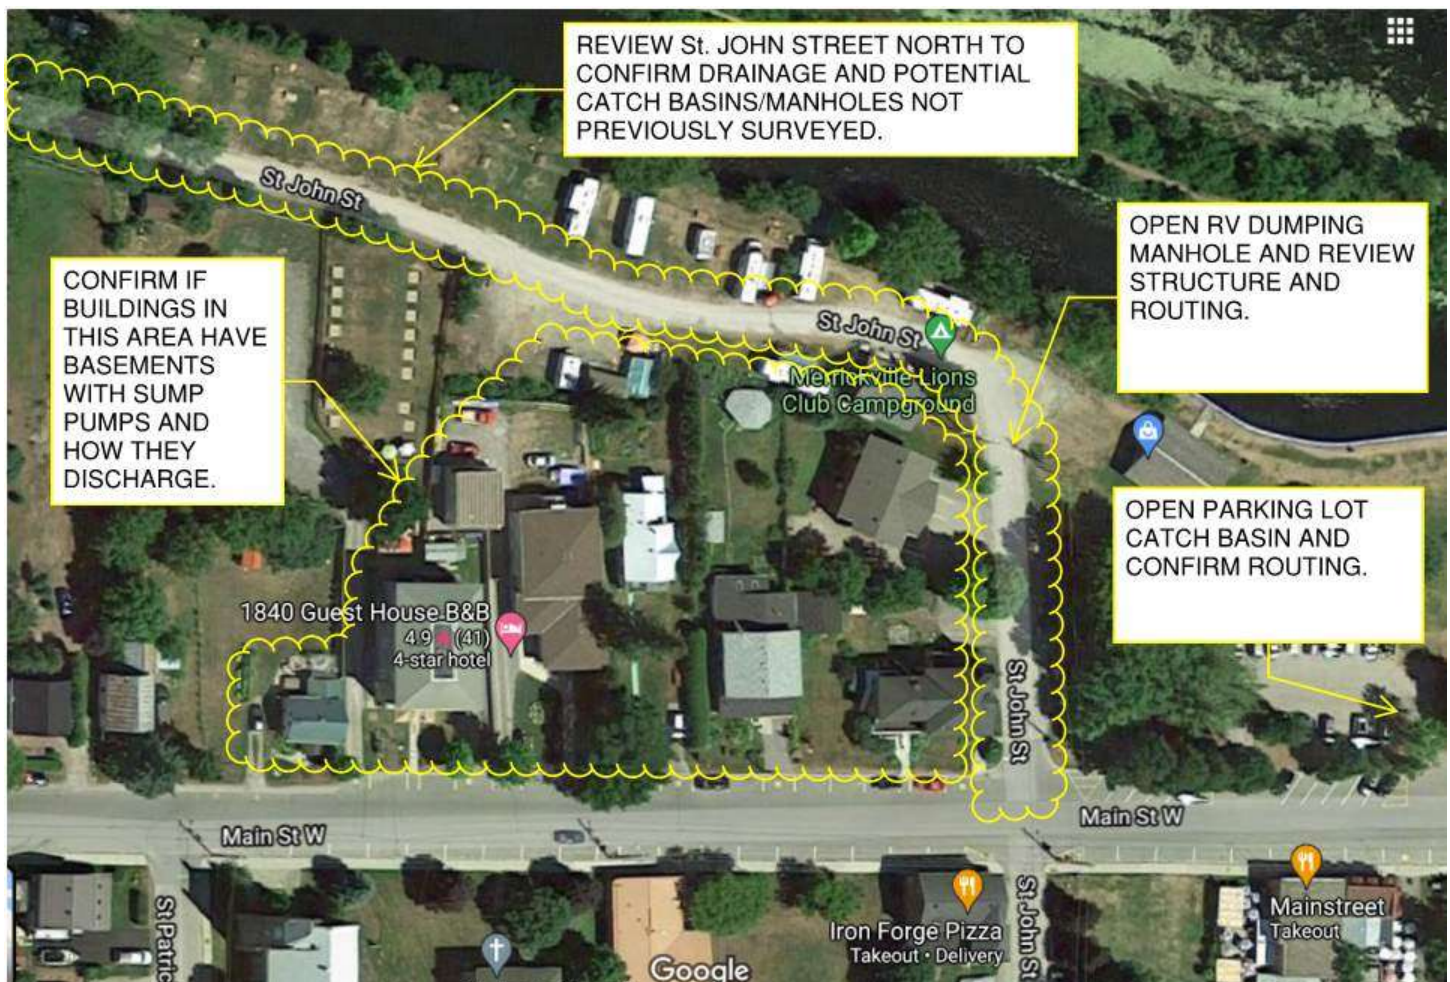
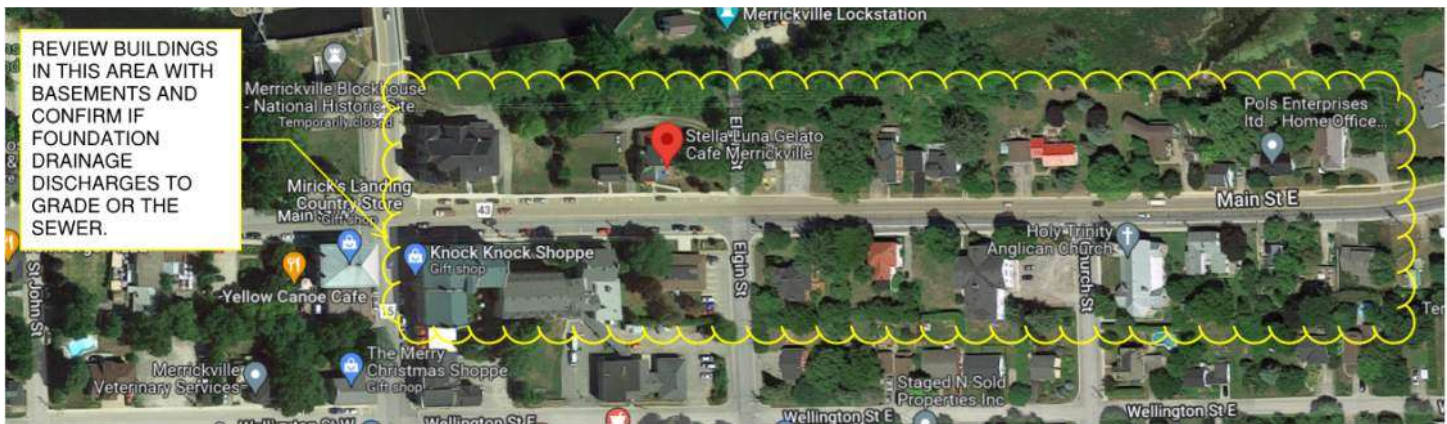
Figure 9: Scope of Proposed St. John / Main Street Investigations

The priority areas for these inspections are along Main Street and the portion of St. Lawrence Street between Main Street and Charlotte Street as the system flows are highest in these areas and groundwater levels are presumed to be highest in these areas. A map of the proposed investigations is provided below.

The municipality should consider enforcing the proposed sewer use bylaw and undertake property-by-property or structure-by-structure visual inspections from the municipal right of way to determine if roof leaders and sump outlets are discharging onto the surface. Notices could be sent to owners where there is evidence of roof leaders heading into the ground and not discharging onto ground surface. Follow-up visits by the Chief Building Official with the owner would confirm the removal of any direct connections.
