Final Infiltration and Inflow Report

Village of Merrickville-Wolford
Merrickville, Ontario

The Village of Merrickville-Wolford
Project File No. 19-5031D

June 2022

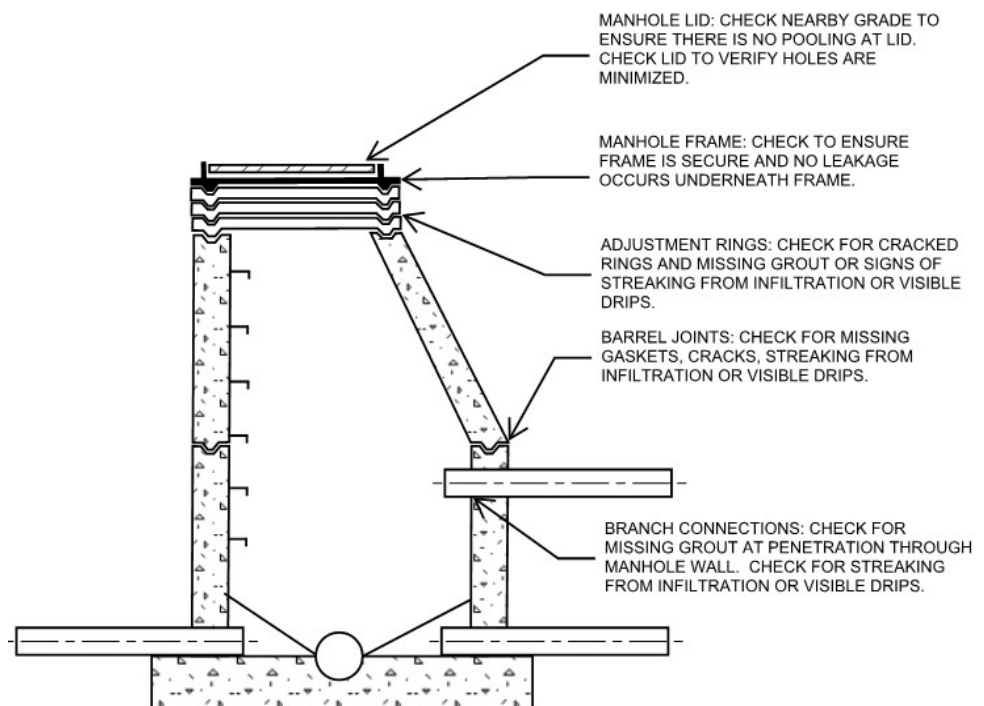
Figure 3: Manhole Structure Potential Inflow Points

Two site surveys were conducted to review the structural integrity of manholes throughout the system. During the surveys the manholes were reviewed for general structural integrity and for typical points of infiltration as illustrated in Figure 3.

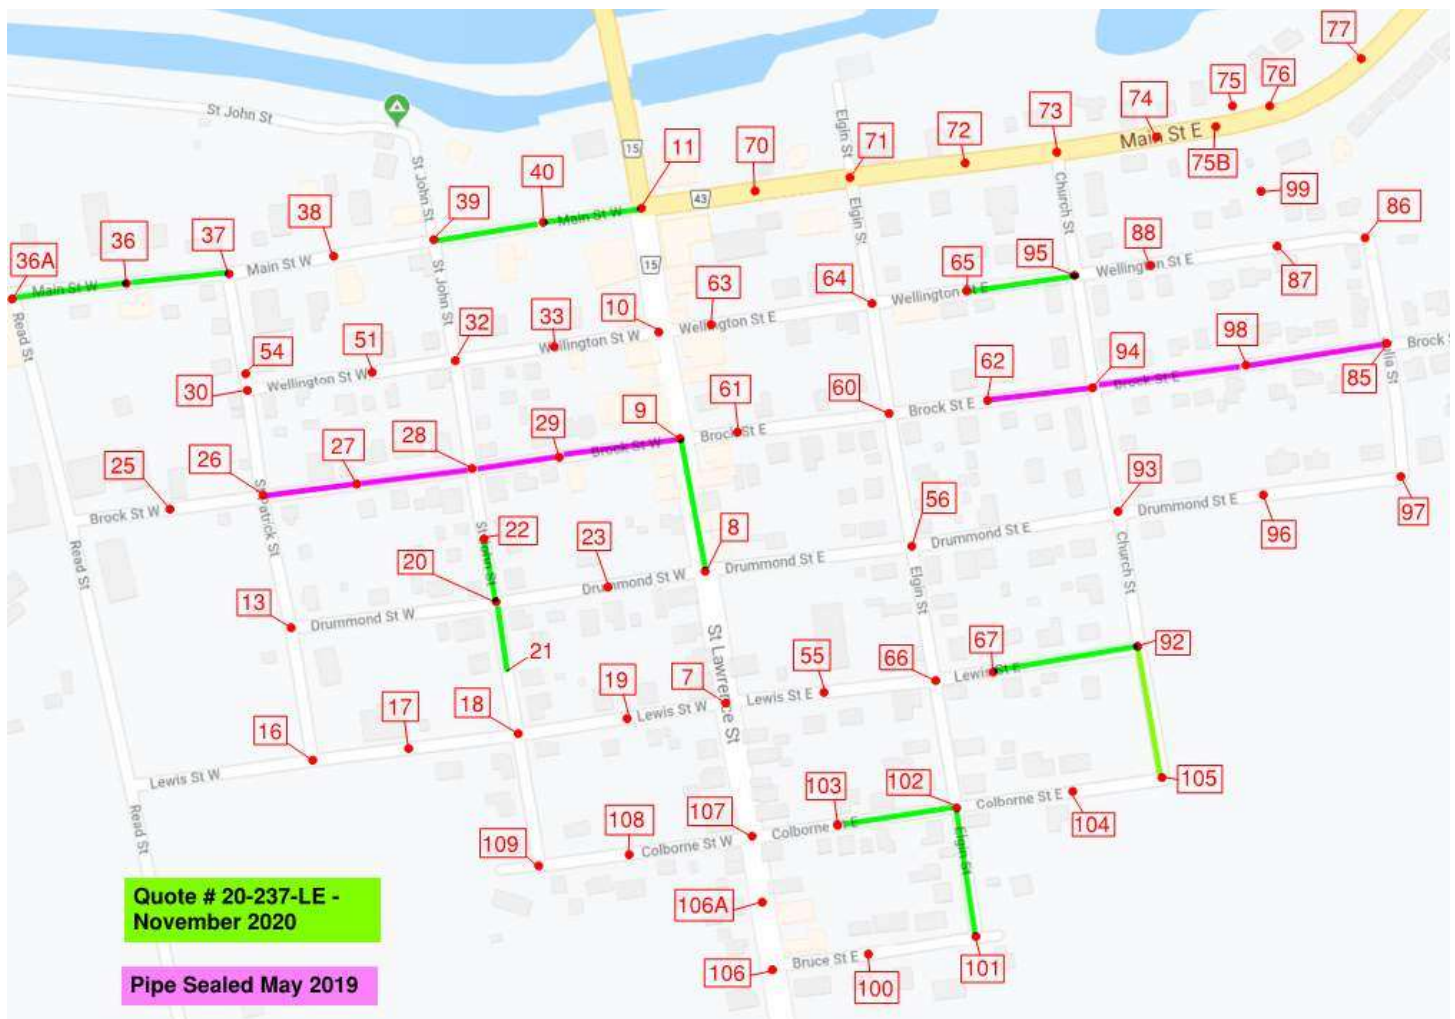
Figure 5: CCTV Report Scope of Work Map

OCWA has been performing CCTV reviews of the sanitary system independently of this study. Detailed results of the CCTV investigation are available in the report 98486SA1 compiled by Clean Water Works and released on January 4, 2021. The report noted structural defects in segments of piping throughout the village, including Main St, St. Lawrence, Bruce Street, Church Street, St. John Street, and Lewis Street. The map of the CCTV scope is provided below for reference.

It is useful to view the CCTV results and recommendations in conjunction with the flow monitor results. The flow monitoring has provided the understanding that the system flows are very high on Main Street and at the north end of St. Lawrence Street and the north end of Church Street, therefore any structural defects noted in the CCTV report in those areas should be prioritized for repair, whereas structural defects noted in the south half of the village would not be expected to provide a large benefit to the system if repaired.
